MAY BONFILS STANTON THEATER FEASIBILITY STUDY

June 21, 2019

Loretto Heights Theater Denver, Colorado

Condition Assessment Report

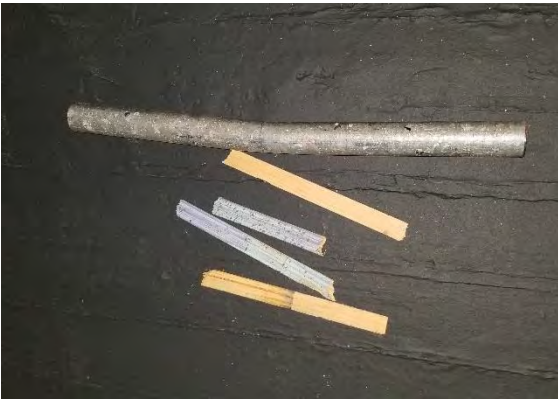
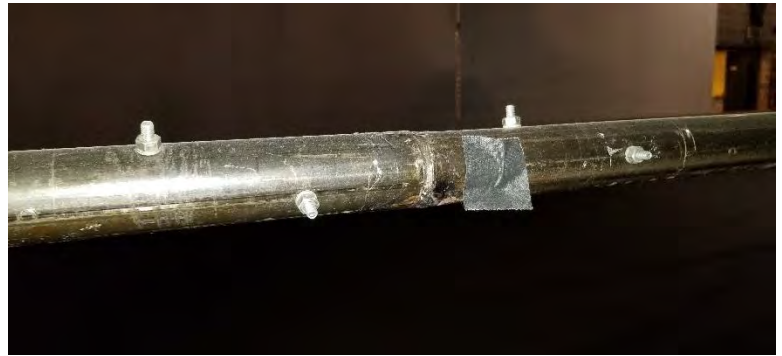
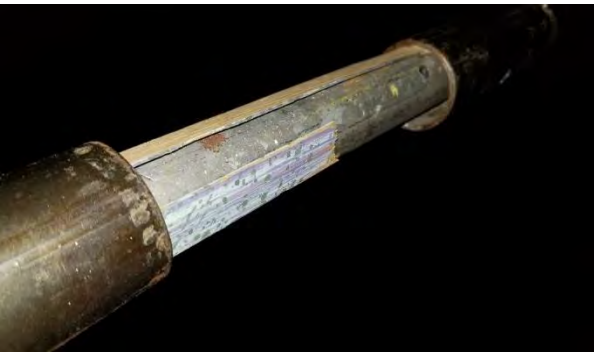
Batten pipe connections gone awry. Tape was tried to keep together one batten. Wood shims were added to try and reduce the gap created by the wrong size sleeve pipe. Battens are bent, not connected using rated hardware for overhead lifting and are past maximum lift line spacing standards for a single pipe.

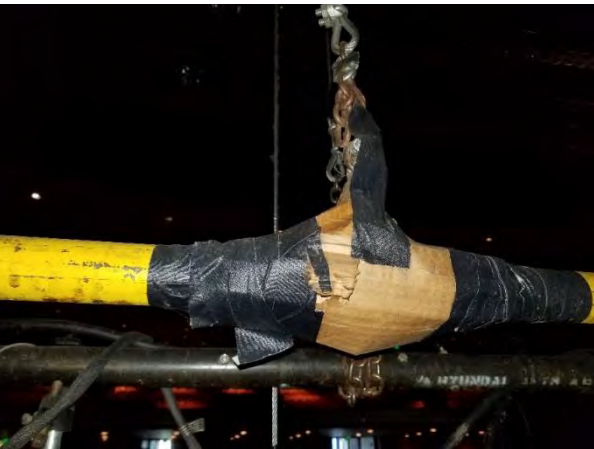
Batten lift line termination covered and taped together. Example of several instances found.

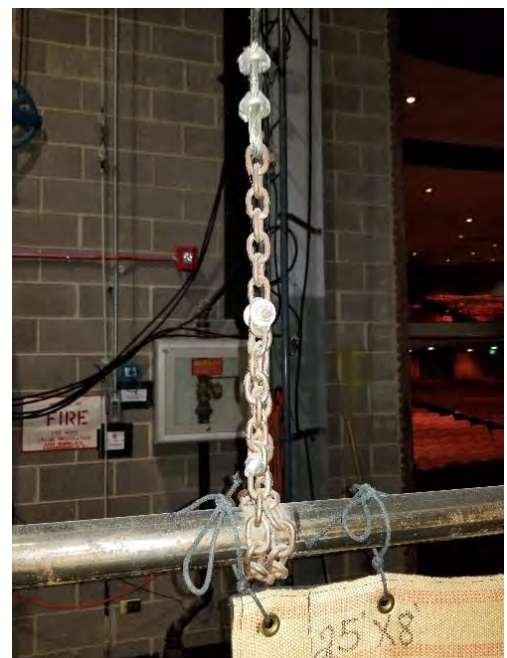
Example of lift line termination hardware. The bolt keeping the two ends of the chain is not rated and should not be used for this purpose. A 5/16" rated shackle is appropriate.

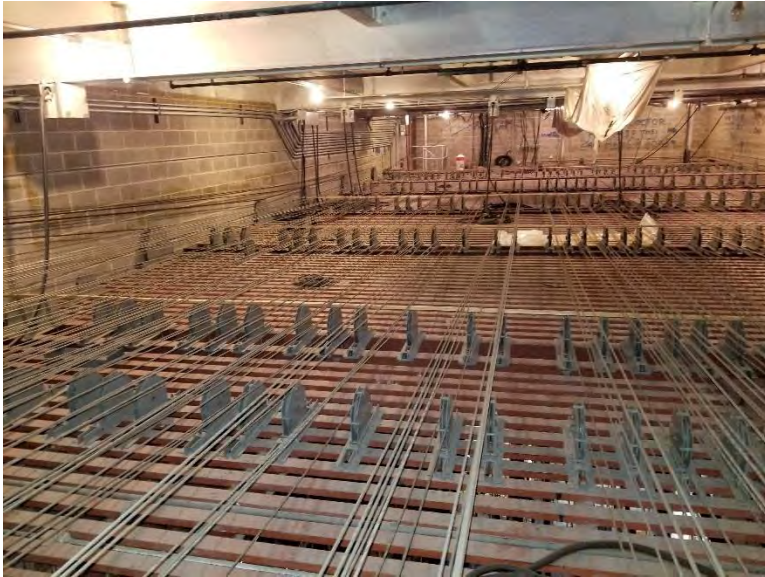
Grid picture showing the wood over top of the loft blocks keeping the lift lines elevated, away from the blocks below. If the wood was not present, the lift lines would be rubbing on the blocks causing friction in the system and damage to the wire rope. Line set 40's lines are not on top of the wood, so the wood should be extended.

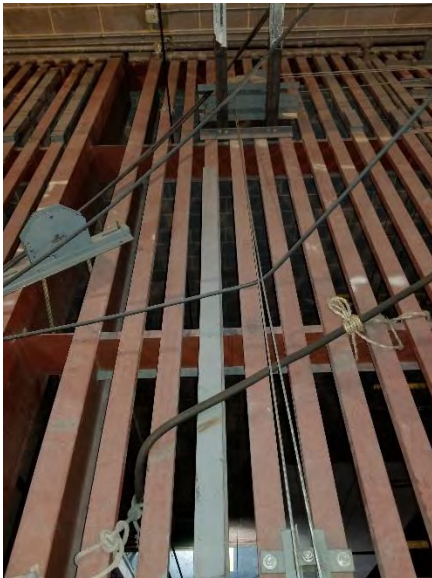
Electric cabling in conflict with the lift lines for the stage transverse batten. Wire rope can eventually saw through the outside jacket.

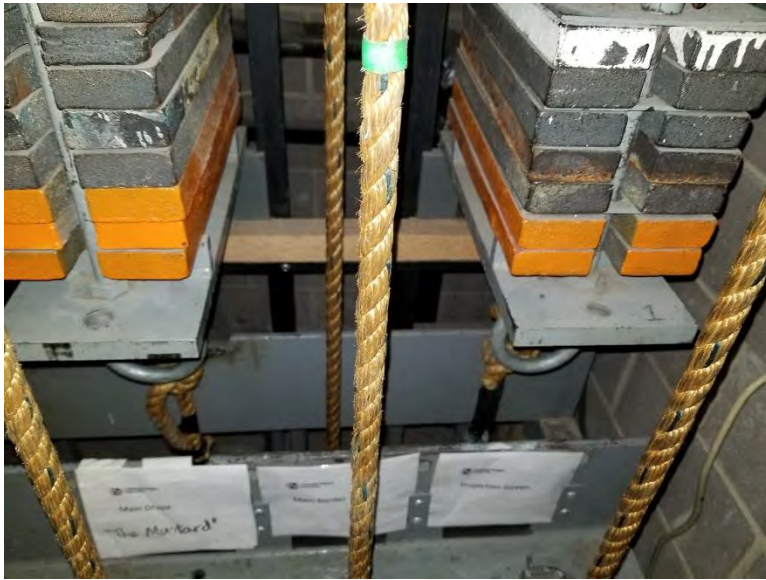
Head block with seven lift lines and the organic, manila operating line

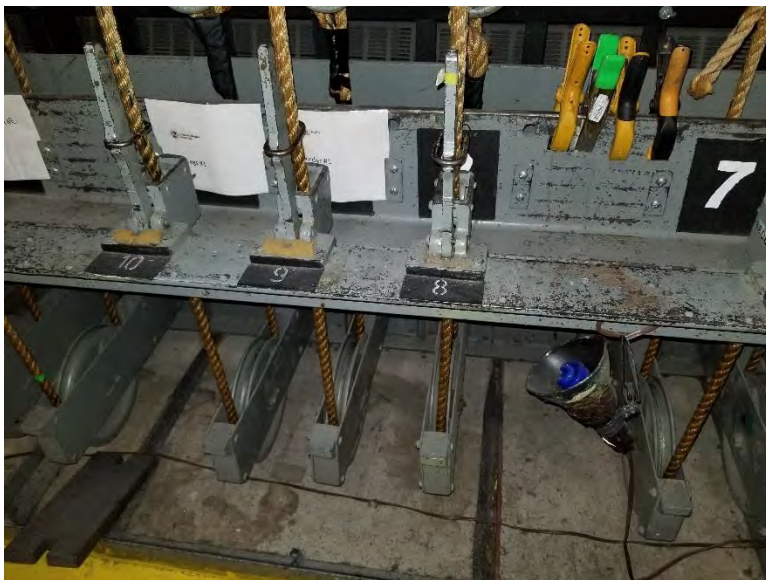
Bottom of arbor, running rail and operating lines

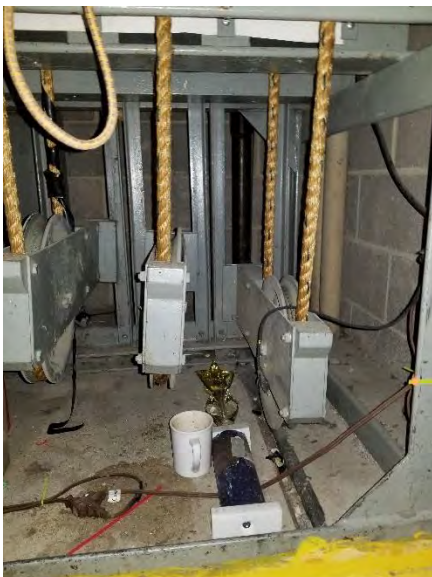
Original rope locks that are only designed to last 15-20 years

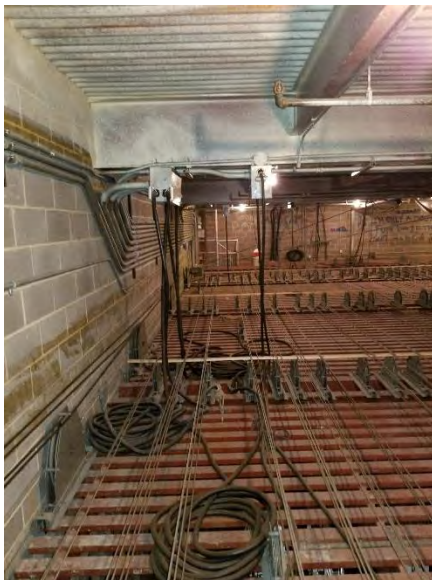
View of cables from the lighting loft heading up to the grid and then back down to the moving battens. Instead of using multicable that contains six circuits, each circuit is run separately

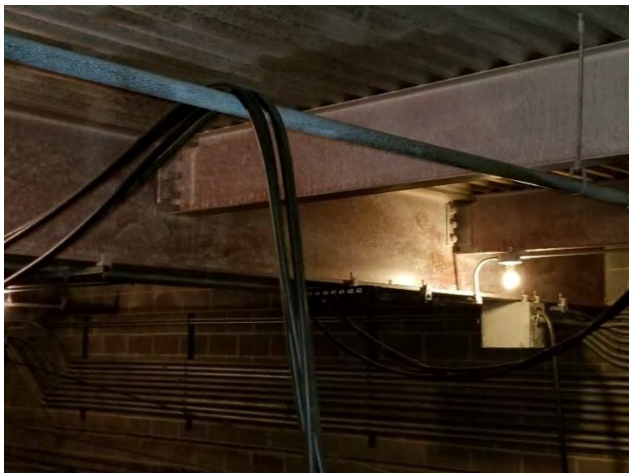
Original theatrical circuits in underhung junction boxes at roof beam. The box on the right needs new mounting hardware to secure it. Ungrounded SO cable lying on the steel grid.

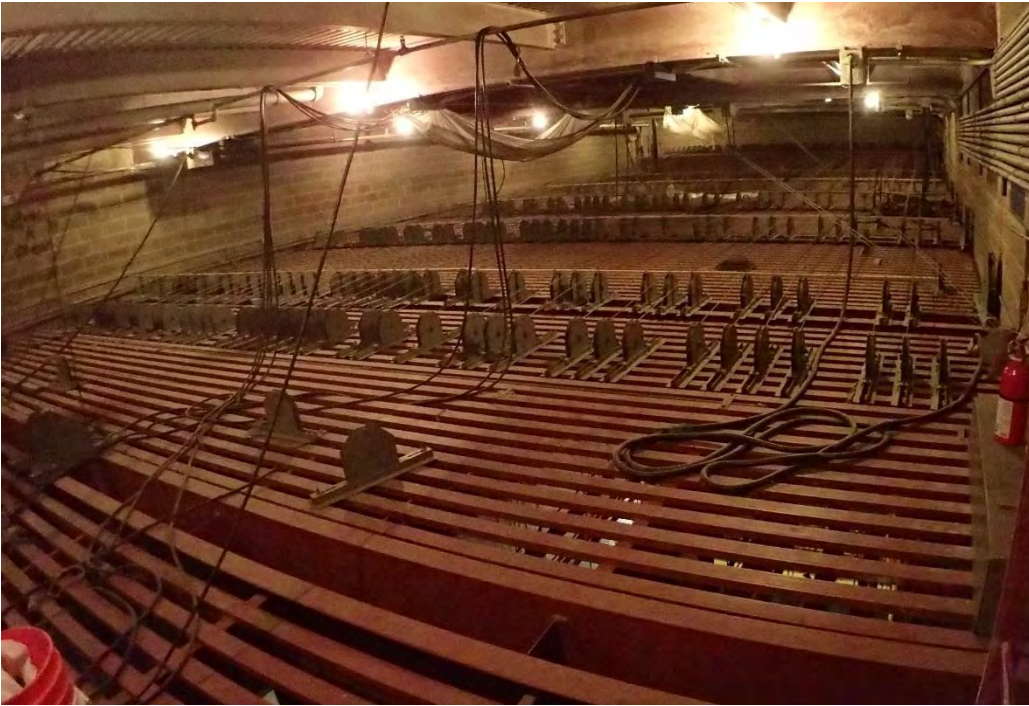
Grid picture of the lack of cable management and the general mess

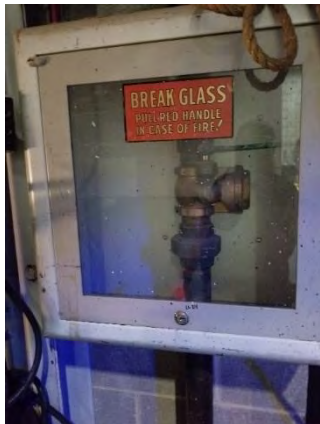
On stage right, this water pipe was noticed to come up through the stage and then continue to run over the proscenium opening. It is probably an old deluge or water curtain designed to flood the area with water so that fire and smoke could not reach the audience.

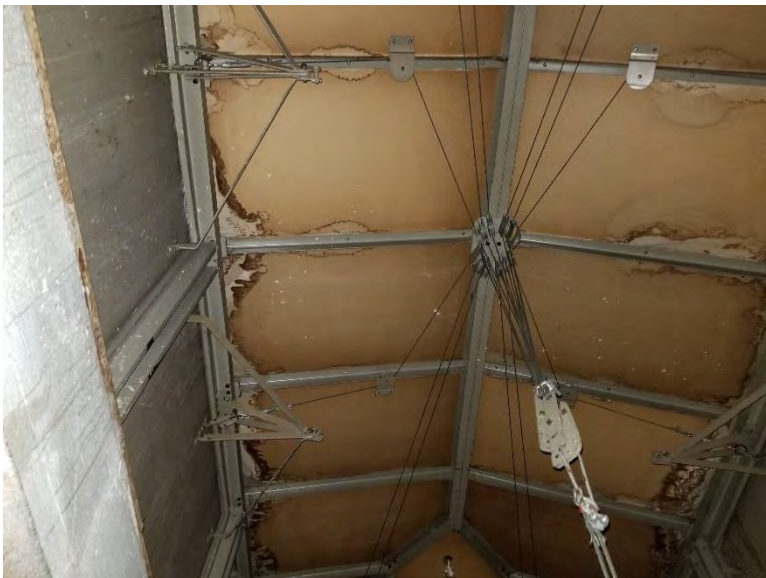
Inside view of the smoke doors. Operating lines come together into one clew and then one pull line heads down to stage right for operation. Doors to be opened from stage in the event of a fire to allow the smoke to escape. This is key for fire fighters to be able to see. Fusible links are also supposed to release the doors automatically once they melt at 165 degrees

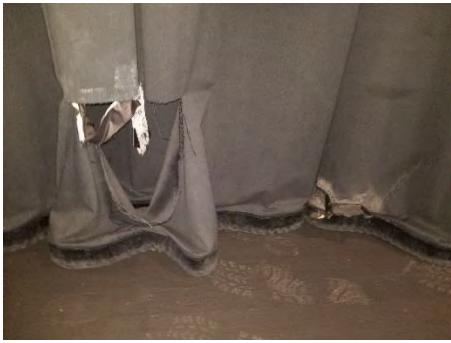
Condition of stage drapes is poor

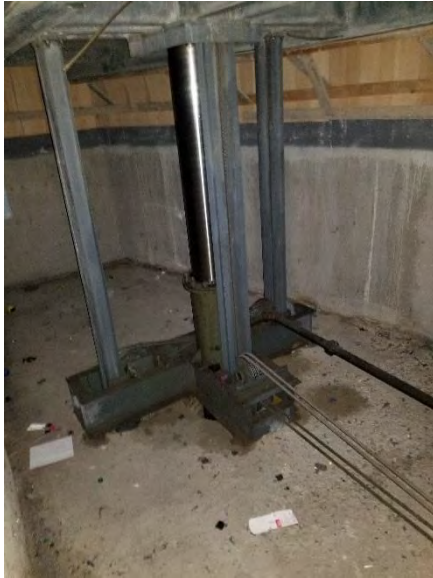
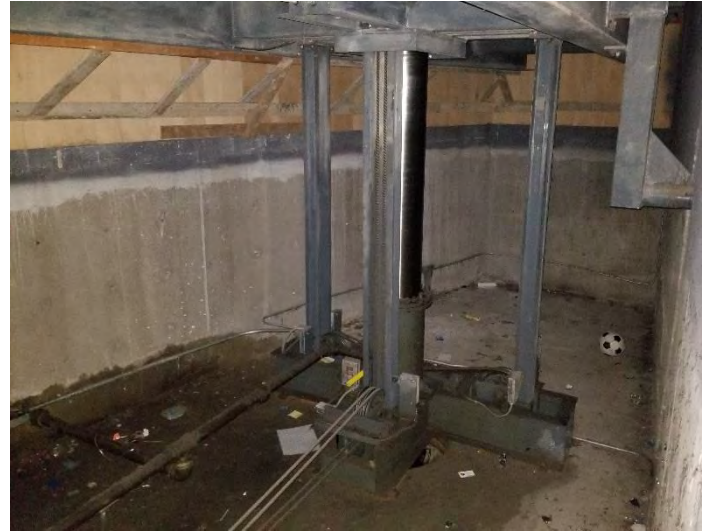
Underside of orchestra pit lift. Stage left side is fairly clean while the hydraulic fluid on stage right appears to be leaking. Rest of hardware appears in good shape

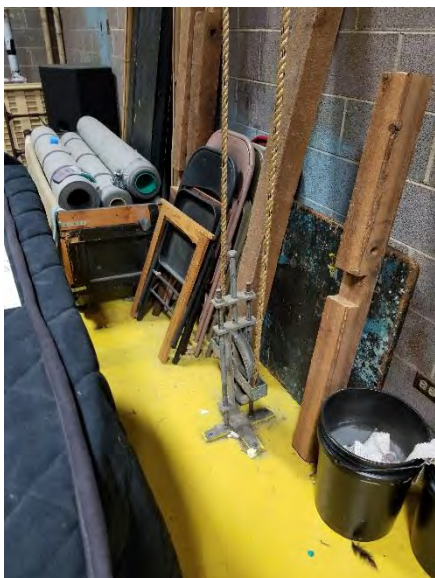
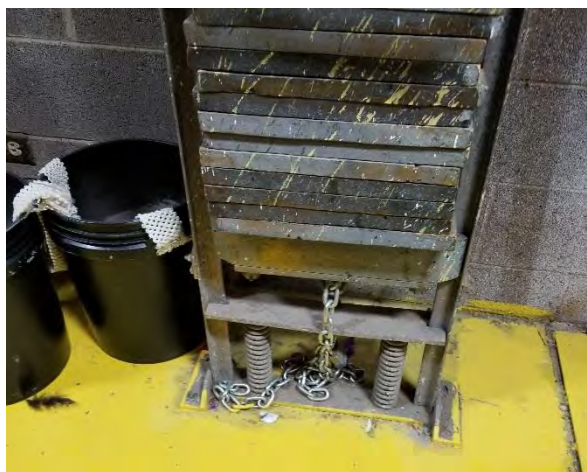
Rigging for rear storage area paint wall. Floor block on right is the control and the arbor shown on the left is the counterweight for the wall and canvas.

Head block at paint wall line set. Set could be restored and the paint wall put back in use

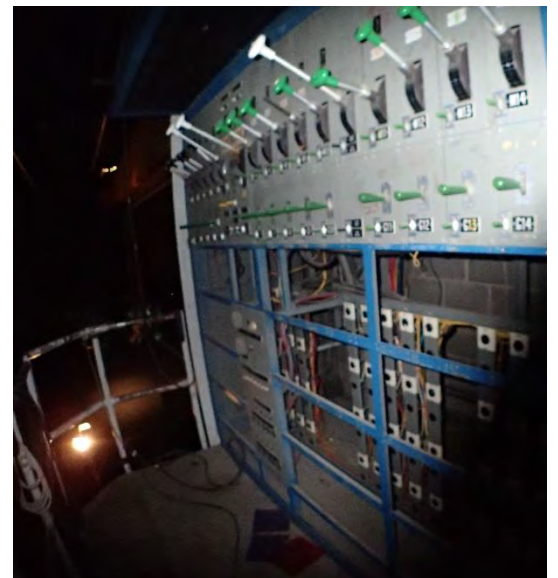
Original dimmers still sitting on the lighting loft floor. Rear of panel is wide open and the circuit wiring still terminates to the buss bars inside the cabinet. Cabinet must be closed up for safety or the renovation completed to remove all the existing lighting controls and infrastructure

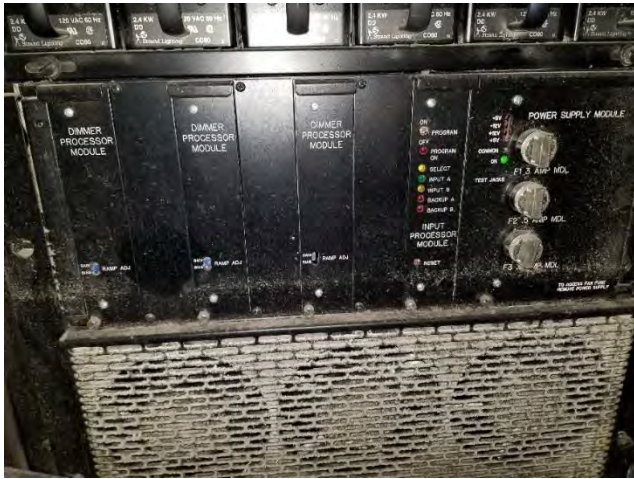
Front, bottom of Strand rack with the original analog controls. Rack can be upgraded with digital controls in one day allowing relay and constant power modules to be added for LED fixture power.

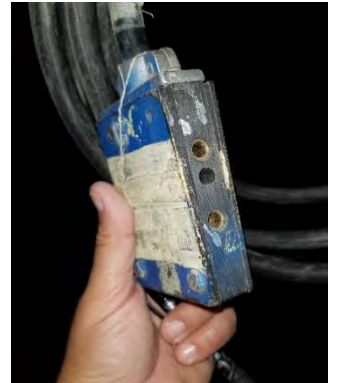
Outlet box attached to the left side of the Strand rack for circuits 61-96. Cabling goes to the onstage battens

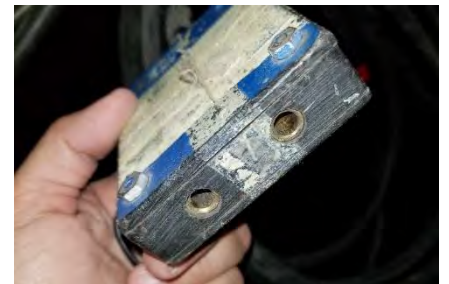
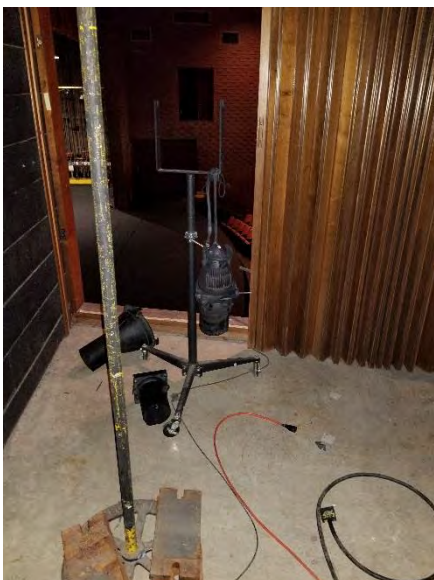
Bottom picture is the original two pin connector style without the third, ground pin. Top picture shows that the technicians tried to drill into the connector to allow the three pronged stage pin connector to be inserted

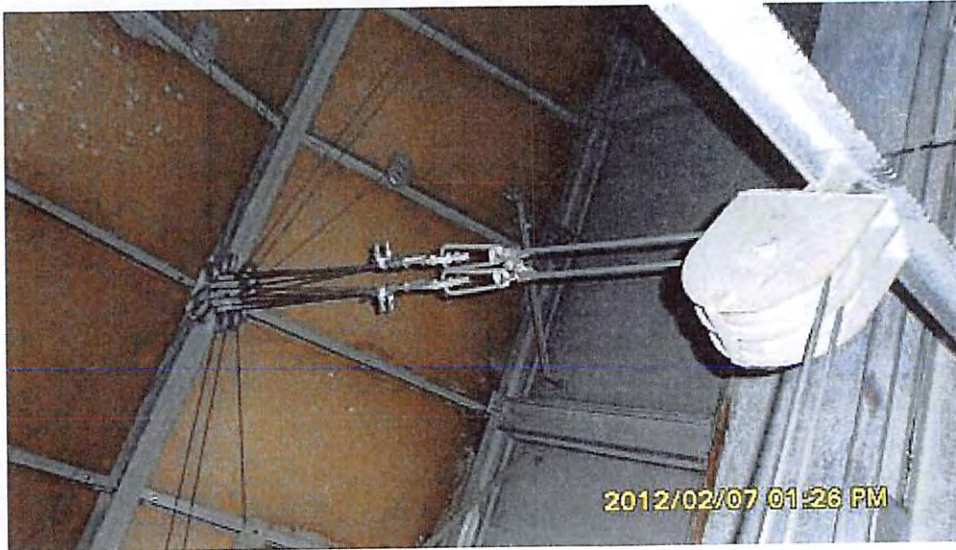
PICTURE #3

CABLE CLAMPS AND DOUBLE PULLEY

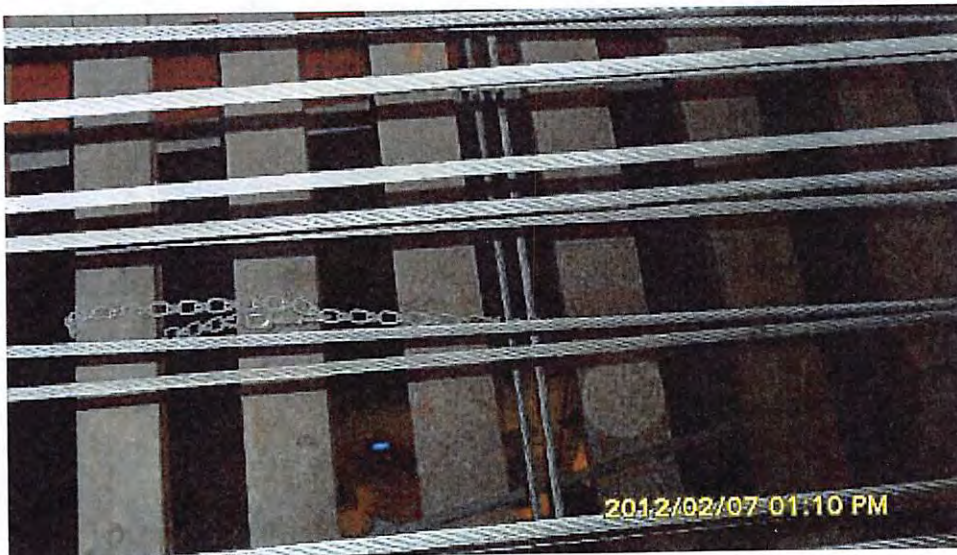
PICTURE #19

SWING SET CHAIN

In the shop area the visual inspection of the paint frames (pic. 19) concluded that the rigging is very good. It was understood that there were not problems moving the frame. There should be a removable hand rail required around the opening in the floor. This would prevent personnel from stepping into the floor opens. In the upstairs area of the shop is a block and tackle set-up to raise and lower equipment to stage level. The use of a block and tackle at this spot is very important due to the small size of the access stairs. The present rigging of the block and tackle should be redone using approved rigging practices (pic. 20).

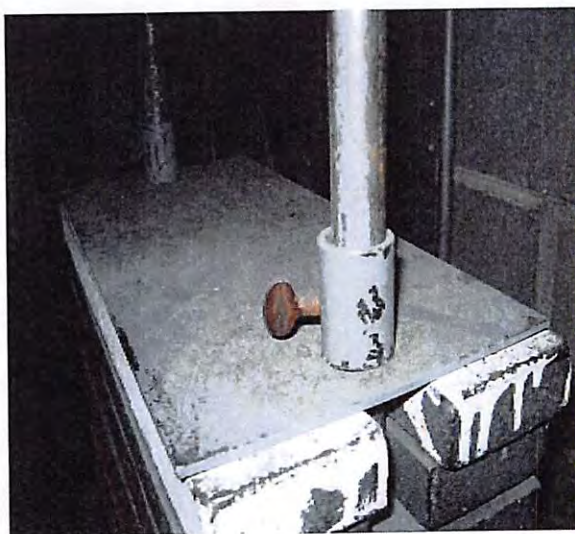
PICTURE #25

There are three (3) major concerns; Rope Locks, T-Bar Track, and the lack of Light Index Bar. All the Rope Locks (pic. 23-25) have reached a point where they do not lock the rope in position. Failure to hold the rope in position could release it; cause the pipe batten to drop or the arbor to fall. The upstage upper level of the T-Bar track has shifted. This is caused by usage and the building settling (pic. 22). Line sets #27 and #40 stick between the tracks making them hard to use. There are 20 or more line sets that rub or bounce over the joints between sections of T-Bars, this cause wear on the arbors shoes. The loss of the Light Index Bar, also referred to as a Headache Bar is an important safety element on fly system (figure 1). Its main purpose is to illuminate the operating rope during show events. Most show event has the back stage in low lighting. The Light Index Bar illuminates only the line sets spike marks. These spike marks prevent battens from coming in too low and damaging equipment or personnel. Because there is no light bar line sets have been secured by rope to prevent moving the line in the dark (pic. 24). The present rope is not tied with a proper lashing practice.

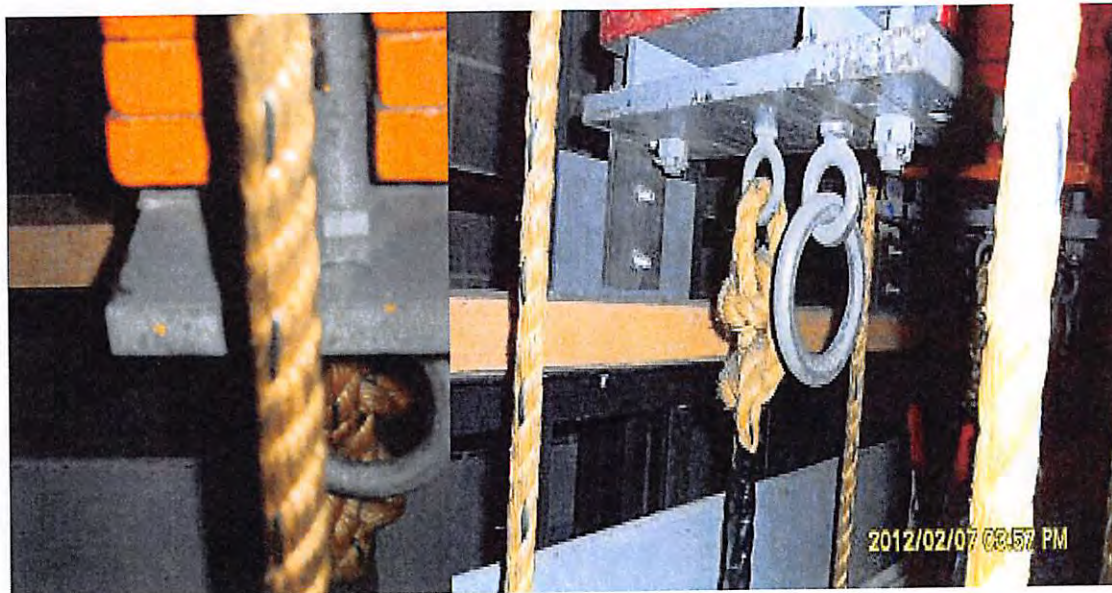
PICTURE #31

made up bottom plate where the operating rope is attached, two metal rods where the counterweights are placed, and a top plate where the operating rope is attached, along with ¼ 7 by 19 aircraft cable. To keep the counterweights secured to the metal rods Spreader Plates and locking nuts are used. Batten weight or sometime called pipe weight is marked by painting the counterweights so they will not be removed this has been done at the theater. Most of the Arbors locking nuts (pic. 26) thumb screws are loose. As in some cases the thumb screws are missing (pic. 27). On the line set #27 the locking nuts are missing (pic. 28). These locking nuts and thumb screws must be tight during operation of the arbor, to keep the arbors steel rods from spreading. The spreading of the rods happens when the arbor hits the stop block to hard (pic. 29 & 30). In addition to the locking nuts, each arbor has Spreader Plates that keep the rods together. The Spreader Plates are designed to be spaced every two foot (2') to insure the rods along the height of the arbor. Presently placement is not correct (pic. 31 & 32).

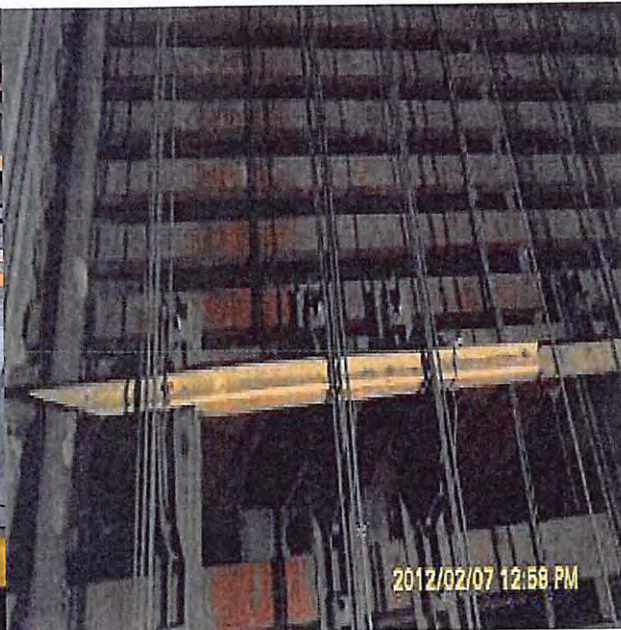
PICTURE #35

The Operating Rope on Each of the line sets is showing wear and grease deposits (pic. 33 & 34). The grease destroys the fibers in the rope. It is D L Staging Place understanding that these ropes were replaced in the last 10 years. The present Operating Ropes have lost 3/32 diameter of its original ¾ inch. This happens from age, usage, and running the rope thru the locks. Because this rope is an organic material, stretching of the rope happened during usage. The stretched rope lowers the Floor Idler Pulley, (also called Floor Tension Pulley). The Floor Idlers on the Fly System are at the lowest level (pic. 22A & 25). During the original installation rope thimbles were not installed causing wear on the rope during operation (pic. 34). The storage of the counterweights on the locking rail is questionable, storage on the floor under the rail maybe a better place (pic. 35).

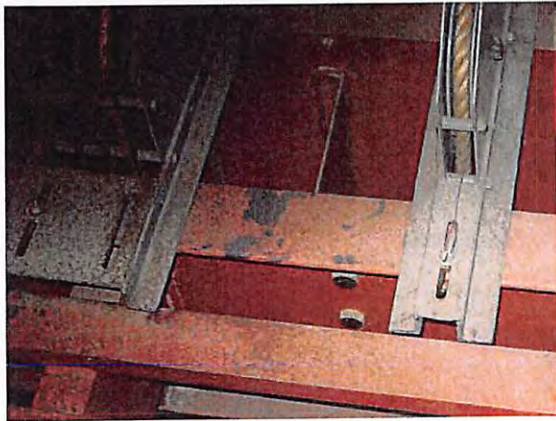
PICTURE #43

On the grid the Head Block is used to distribute the aircraft cable to different Loft Blocks. Each line set has one Head Block and seven Loft Blocks. The Loft Block turns the cable down to be attached to the Batten pipe. There are two Head Blocks that have loose bolts (pic. 43). The aircraft cable has a long run to the far Loft Block, to prevent sagging and catching on the blocks wire guides are used. These guides are either wooden or small pulleys attached to the Loft Blocks. The wire guides are attached to the Loft Blocks with 12 gauge electrical cable (pic. 39). Some of the boards are loose (pic. 37), or a different kind of wood (pic. 36 & 40). Standard wire guide that are wood use hardboard like oak, most of the wood use in the theater is soft wood like pine. A better way to attach the wood should be found. There are a number of Loft Blocks that have the attachment clamps securing the block to the grid turned (pic. 40 & 41). Some Loft Blocks need alignment so the aircraft cable does not rub again the loft block (pic. 46), or twist the aircraft cable (pic. 42 & 44). The Rope Loft Blocks used to lift electrical cable for the Electric have butterfly nuts securing the block. These nuts are not rated for this usage (pic. 45).

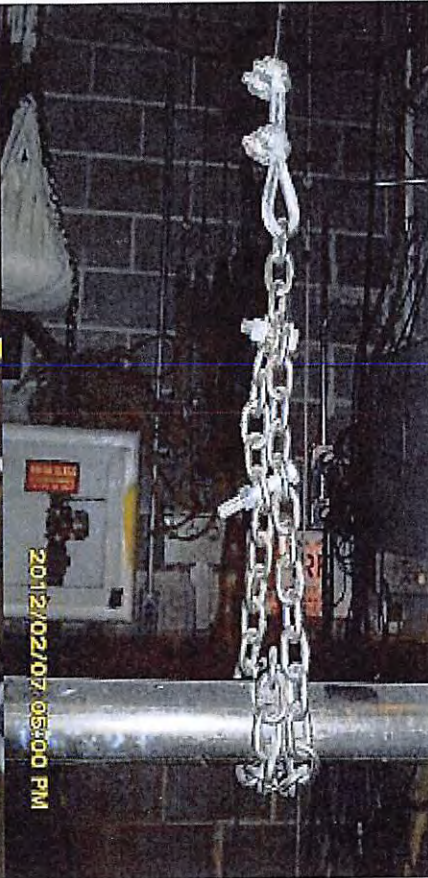
PICTURE #48

On both stage left and stage right there are electrical side battens. These are line set #36 and #37. They are mule block to help change the angle of the aircraft cable. The attachment of the aircraft cable is questionable, due the fact we are unable to fly the batten in (pic. 47 & 48).

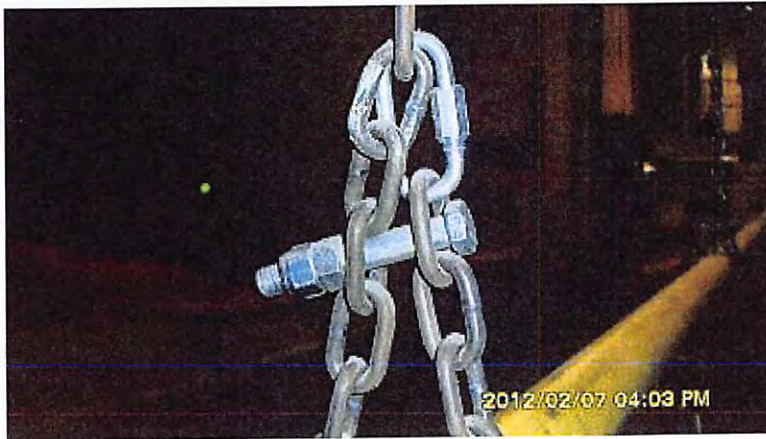
PICTURE #49

The stage Battens are connected to the Aircraft Cable lifting lines by chain double wrapped around the batten pipe and secured with a Quick Link and Safety Bolt. The Quick Link rating is unknown, but based on the size it is about 750 pounds (pic. 50). Bolts are not designed for the side force generated by the chain, and have been replaced in stage rigging with Quick Links or Shacks. The Quick Links is the only thing that can be used. A number of line set are using only bolts to secure the chain (pic.49). There is a lot of bolts to close to the Quick Links (pic. 50), or the chain is to long (pic. 51).

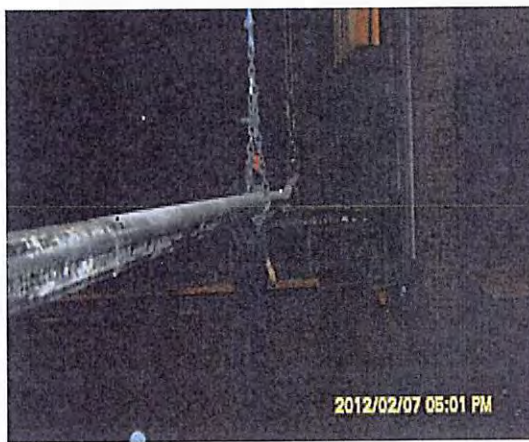
PICTURE #52

Three of the line sets have the aircraft cable lift line at the splice on the batten. This is the weakest part of the batten (pic. 52). There are a few battens that are bent line sets # 7,# 13,# 22 as show in picture (53 & 54). There are a few battens that have different trim heights which vary as much as 2 or 3 inches. The battens get bent from too much weight at a given point or by running into something. Line set #30 has a pipe tie on it (pic. 55). On line set #1 the movie screen has been hung. It is set-up to be taken off the batten and stored, whenever the batten is needed for a show. The Chain work is not rated for this application, because the clips can accidentally become open (pic. 56 & 57). Quick Links or shacks should be used. The turnbuckle on the center part of the Movie Screen rigging is not rated, duct tape hock, and is not dogged off (pic. 58).

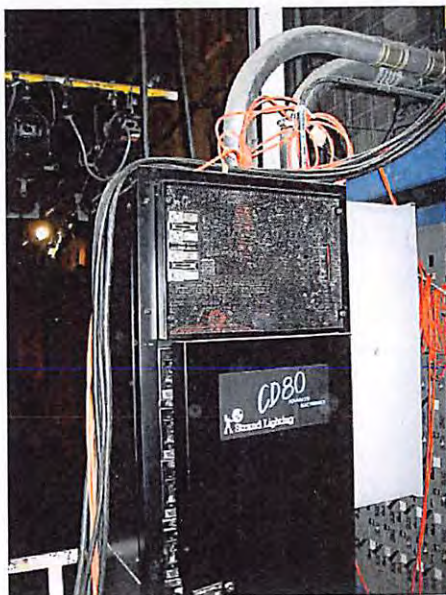
PICTURE #64

The Stage Lighting original system was an Auto Transformer with a pluggable patch bay system. (pic. 61 & 63). At some point in the early 80's the lighting system was updated with Strands CD80, 48 dual dimmer systems (pic. 65). The theater lighting system is now both CD80 and Auto Transformer with the house lights on the old system (pic. 64). The CD80 dimmer system is very dirty (pic. 65-69). The dust and dirt damages the electrical components of the dimmer rack, plus could cause electrical fires. There is a patch bay that adds the multiple plugging zones (pic. 70). The major concern is the wiring of the system. The system is a two wire system with one hot line and one neutral with no grounding (pic. 71-74). In this system of only two wires some time the neutral is shared between hot leads. Both of these practices have caused electrical fires and electrocution.

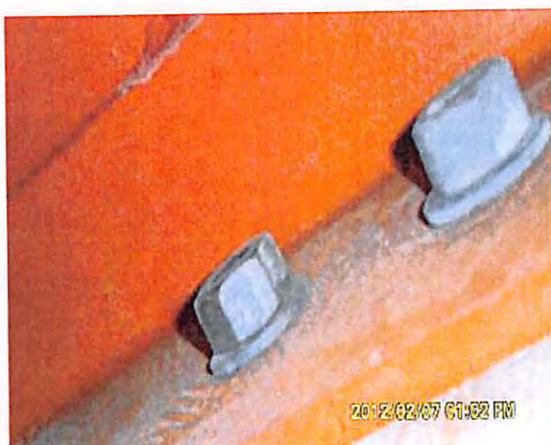
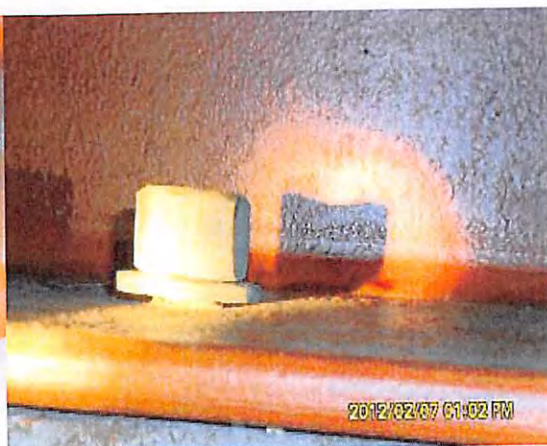
PICTURE #92

GRID SUPPORT BOLTS

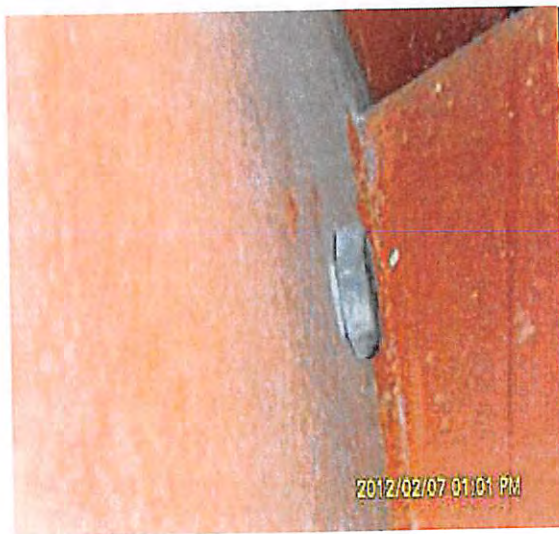
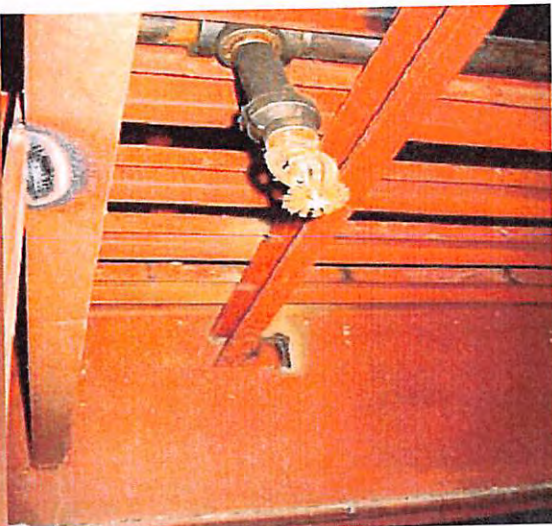
PICTURE #94

GRID SUPPORT BOLTS

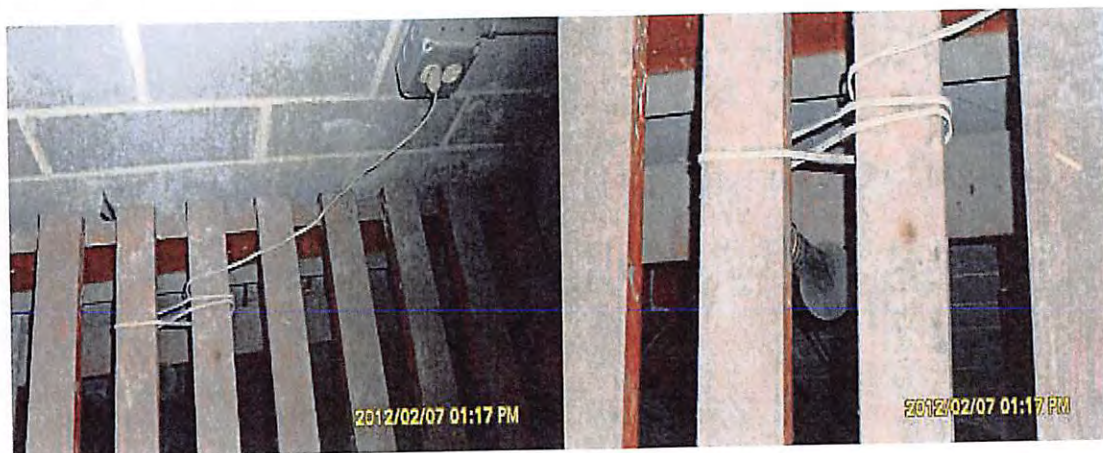
PICTURE #103

It was found on the grid; a light plugged in to an outlet then hung below the grid (pic. 102 & 103). Picture 104 shows a breaker panel box with exposed openings where breakers have been removed caps should be installed.

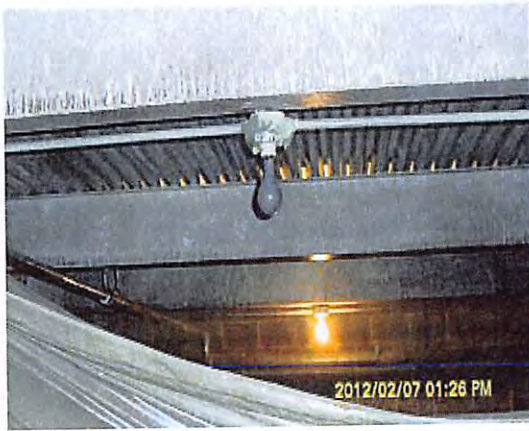
PICTURE #106

There are a number of bare light bulbs on the grid and catwalks (pic. 104 - 107). In picture 105 it can be seen how close the bulb is to the head of a person. These should have metal cages around the bulb. Throughout the areas electrical cables have been laid across walkways (pic. 109 - 112), and in one case electrical cables are above a doorway (pic. 112). These cables should be covered with carpet, taped, or re-directed, so tripping is prevented. On stage left behind the Fly Rail is a cueing light (pic. 113). There are exposed wires visible.

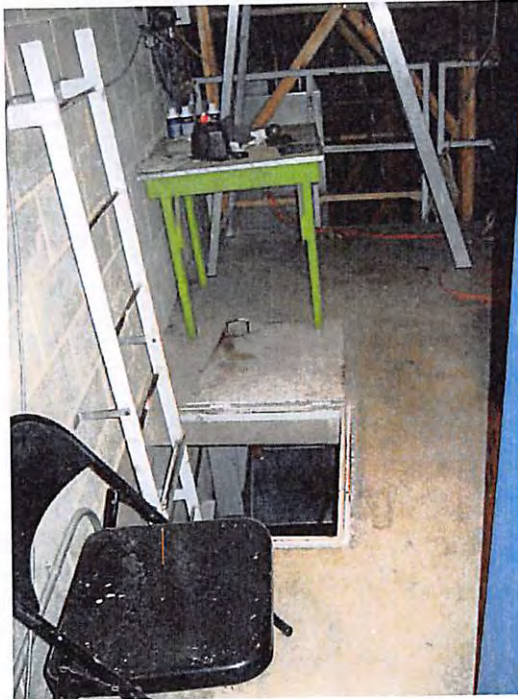
PICTURE #114

Access to the dimmer rack area can be done by a stairway or by ladder thru the floor. The opening has a metal door to cover the hole when not in use (pic. 114). The door is open and unused, by the fact that a table leg is covering the door. The ladder had come unbolted from the wall and is being secured with a wire tie (pic. 115). There are no general work lights in this area, so a stage work light is being used. To keep the light fixture in place a wooden stage brace tied and taped is being used (pic. 116 & 117). This should be redone.

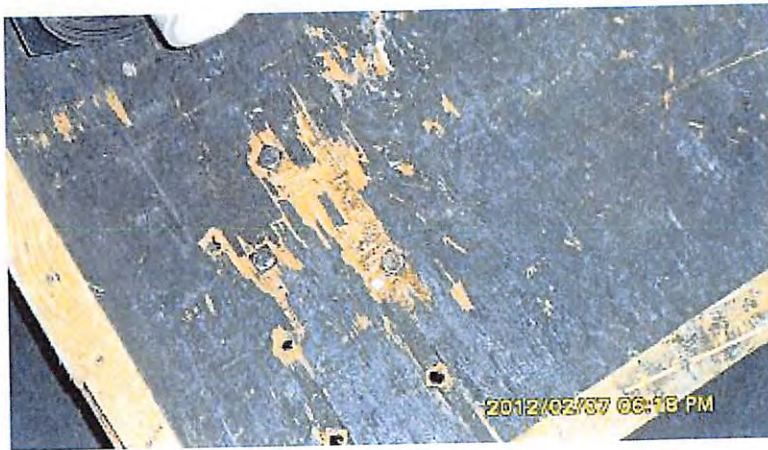
PICTURE #118

In the shop area an access trap door is used to lower items to the floor below (pic. 118 - 120). The plywood has holes, tears, and soft spots in the wood (pic. 118). The covering should be replaced and a removable rail system employed when the opening is used. This trap door is a very important aspect of equipment handling.

- Paint Frame – Removable handrail – door to paint well.
- Trap Door to Loading Dock – replace trap door – install chain motor for hoisting equipment/props/set pieces.

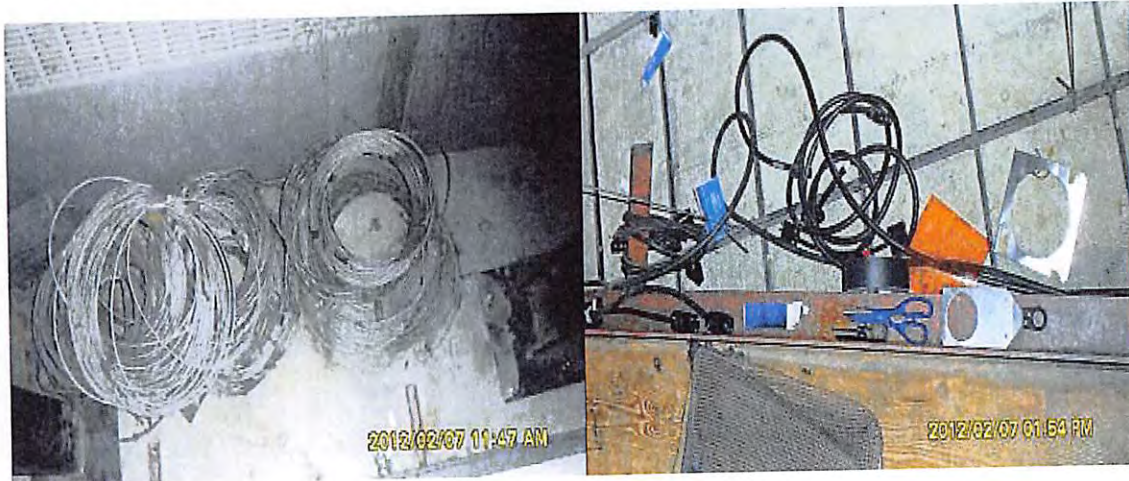
PICTURE #130

A safety hazard on the locking rail are the rope tie-offs (pic. 129). Because of the design of the tie-offs the point could impale personnel, therefore they should be removed. The last hazard D L Staging Place noticed is housekeeping. Too many times in theatres, time and personnel are not given the opportunity to handle basic housekeeping. Slowly over time little things left undone start to pile up. These piles became a way of life or a way of doing things (pic. 126 - 135). It is D L Staging Place understanding the new management is working on changing these conditions and instructing personnel on housekeeping duties.

- Rope Tie Offs – remove rope tie offs that are currently on the fly line locking rail.
- Fly System – replace ALL bolts and nuts not rated for rigging.

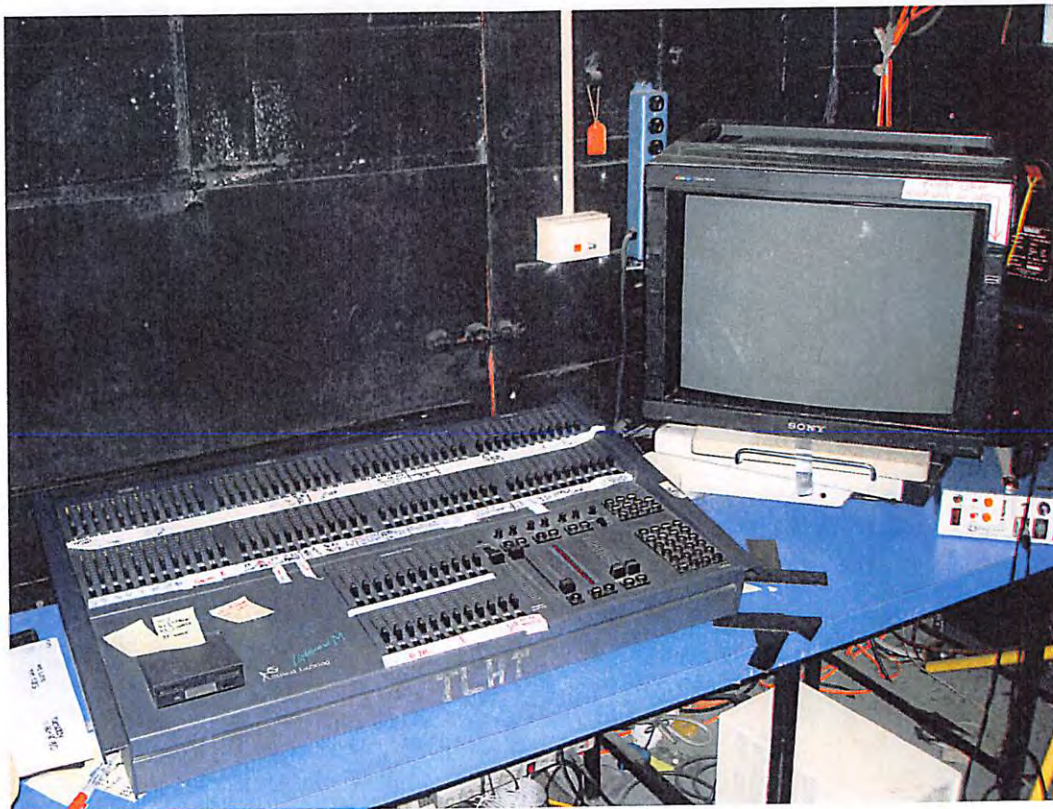
EXISTING LIGHTING CONSOLE

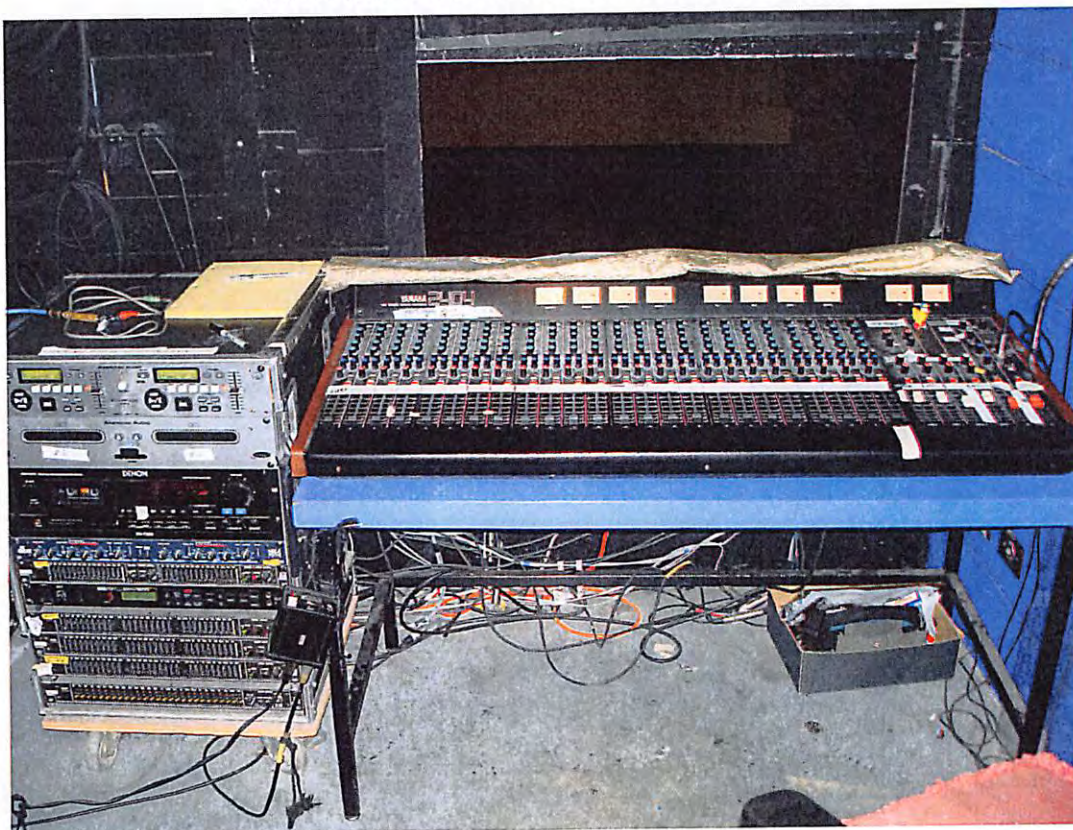
EXISTING AUDIO CONSOLE

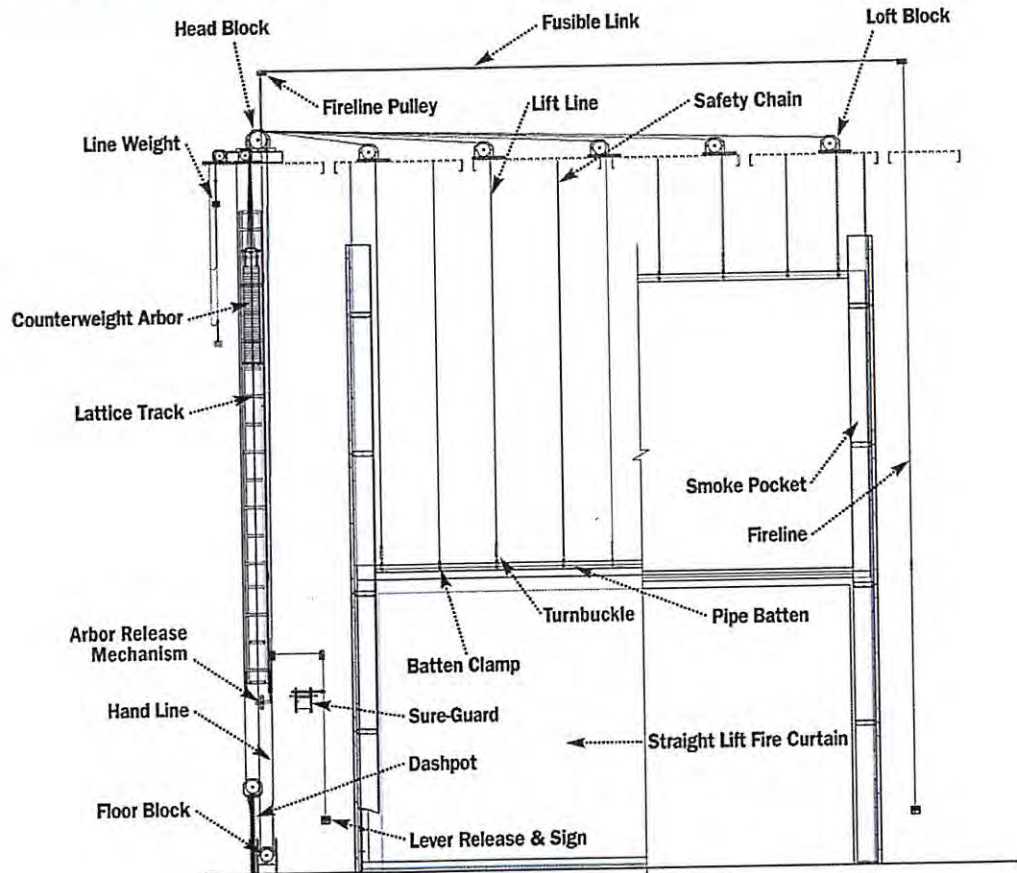
Straight Lift Fire Curtain

The Straight Lift Fire Safety Curtain system is used when the available space is more than twice the proscenium height. It uses a counterweight set to balance the weight of the curtain. Motorization is possible using a traction drive winch in place of the head block.

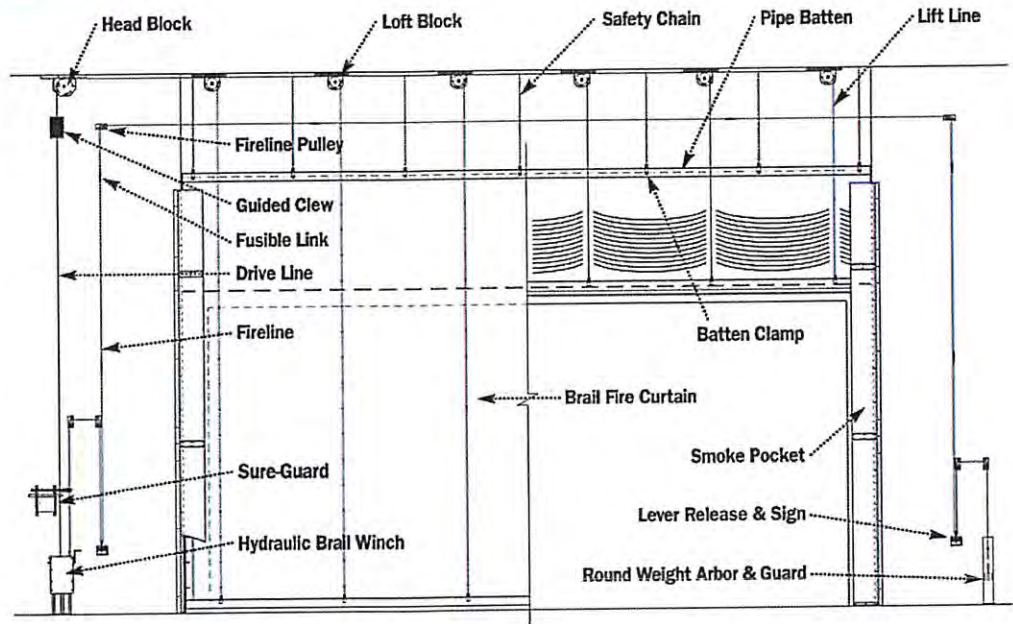
Brail Fire Curtain

This system is used when the space above the proscenium is as small as half (or even less) the height of the proscenium opening. The curtain folds up on itself as it is raised, allowing it to fit in a reduced height. This type of curtain is not counterweighted, but is operated by a fire curtain winch. Both manual and powered winches are available.
